historic structure report  
architectural data section  
volume 1  
june 1985

HISTORIC STRUCTURE REPORT

Architectural Data Section

LINDENWALD

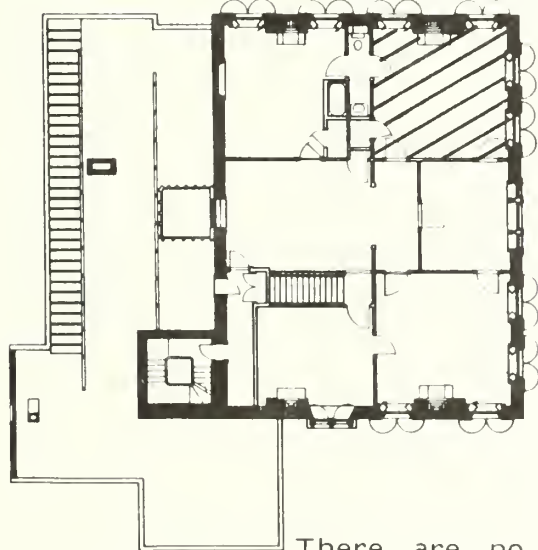
c. Room 205 - Guest Chamber

This second-floor bedroom is in the northeast corner of the ca. 1797 house. Primary access is from room 207 (D204), and another door opening in the south wall (D203) allows passage from room 208. Two door openings in the west wall (D205, 206) provide access to closet space. The opening at the north, into room 203, also permits passage into room 201. There are two windows in the east wall (W206, 207) and two windows in the north wall (W208, 209) flanking a chimney breast.

Make miscellaneous plaster repairs and stabilize, particularly at the south end ceiling along the east wall where the ca. 1960 lowered ceiling contacted the walls; fill the small south wall opening.

Repair (and replace) the nonhistoric masonry work at the rear wall of the firebox, and mortar fill between the stone lintel veneer and brick.

Remove the 20th century sash locks and replace with ca. 1840 reproductions; replace the window 207 stop; replace the HL hinges on windows 206 and 209.

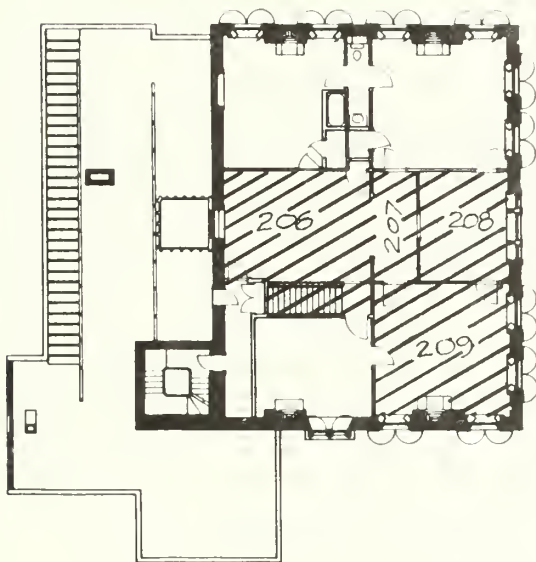
d. Rooms 206/207/208/209 - Stair Hall/Game Room/Entry/Two Chambers

These four rooms are grouped together because of their inextricable relationship in the original and ca. 1849 plans for the second floor rooms of Lindenwald. In the ca. 1797 second-floor plan, room 206 was the upstairs hall, containing the U-shaped stairs. Rooms 207, 208, and 209 formed one large room, possibly a ballroom. (Ascribing the function of a ballroom to room 207/208/209 is only hypothetical. No documentary evidence indicating this use has been found.) By the time Van Buren purchased Lindenwald, the existing room divisions had been built. Room 206 continued to function as the central hall, with

Make miscellaneous plaster ceiling and wall repairs.

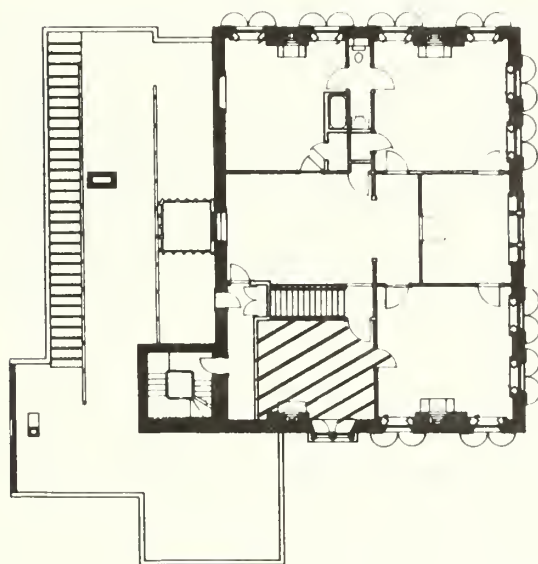
e. Room 210 - Chamber

This second-floor bedroom is in the southwest corner of the ca. 1797 house. Access is from a door opening in the north wall from the central hall (D215, see IP052). There is a door opening (D216) in the east wall leading into room 209, the southeast bedroom. The bay window in the south wall has two round-headed windows (W215, 216, see IP053). A chimney breast is also located in the south wall.

- Clean the shutter pulls and replace the center mullion hardware for securing shutters in a closed position.

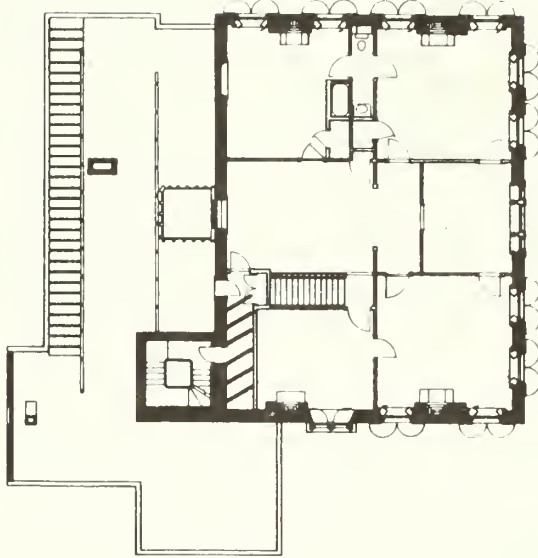
f. Room 211 - Hall

Room 211 occupies a narrow rectangular space in the extreme southwest corner of the 1797 house (see IP054). This passage from room 206 to the tower stair hall and to the Upjohn attic was separated from room 210 in 1849. The door from room 206 (D211) is in the north. Doors into room 213, the Upjohn attic (D212), and room 212, the tower stair hall (D214), are in the west wall. There is a closet in the north end of the east wall, and the lower portion of window 315 is in the south wall.

The ca. 1797 to 1849 use of this space was as part of the bedroom, room 210. The location of the west wall window was approximately 5' 4" from the south plaster wall. Infill masonry is currently exposed south of door 214, the probable location of a window in the ca. 1797 house.

- Restore all woodwork to a tan color (Munsell 10YR 8/2, Benjamin Moore GB-60).

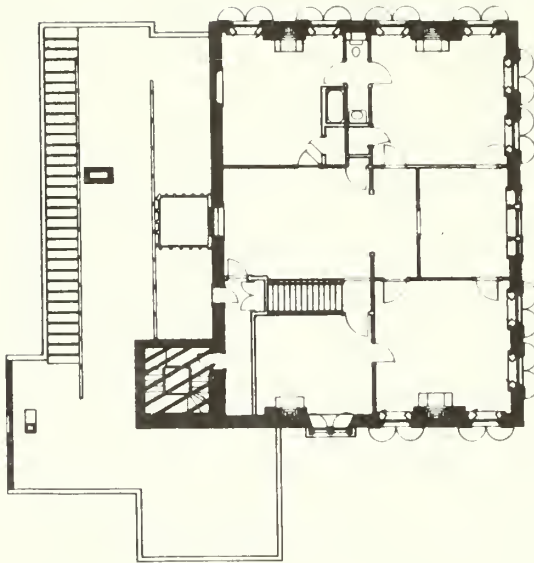
g. Room 212 - Tower Stair

This room is the second floor level of the 1849 tower. The first floor of this stairhall is described as room 113.

The stair begins at the north end of the west wall in room 113 and makes continuous quarter-turns in a series of five risers with landings and winders up to the level of room 308. The entire construction is a cantilevered support system with various sizes and configurations of wood joists pocketed into the exterior brick walls (this construction is partially exposed in the third-floor area where plaster has been removed; see IP068). There are individual arched

Restore the treads and risers to a light brown color (Munsell 10YR 6/2, Benjamin Moore ET-45).

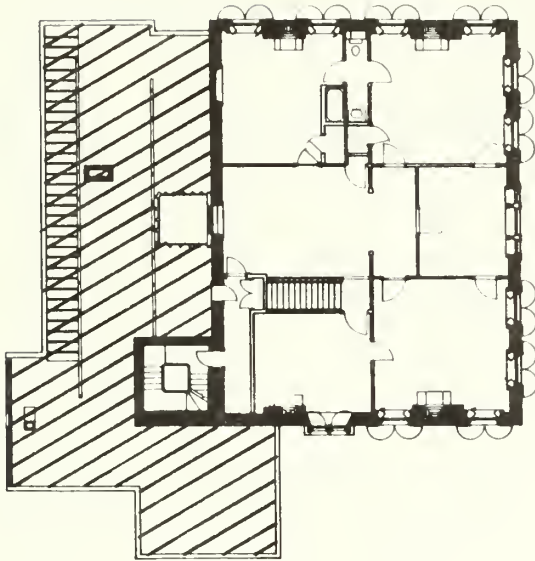
h. Room 213 - 1850 Attic

Room 213 is the entire attic space above the one-story addition except the tower stair and skylight. This space extends along the entire west wall of the 1797 house, wraps around the tower at the south end, and extends around a small portion of the south wall of the 1797 house. Access to room 213 is from room 211 through door 212, and up one 12-3/4" step.

All areas are unfinished open rafters, two parallel roof trusses, and steel jack posts at the north end. All areas have wood flooring except immediately west of the west truss where the floor joists are exposed and filled with

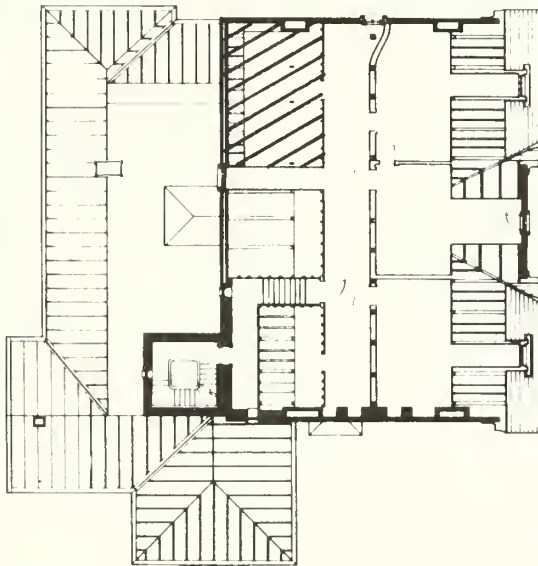
b. Room 301 - Attic

Room 301 is in the northwest corner of the third floor (attic) of the 1797 portion of the house (see IP059). It is a rectangular space approximately 14' by 21'. Since it has no windows and the walls and ceiling are not finished, it is assumed to have been used for storage only.

The east and south walls are constructed of wood studs, most of which are reused lengths of architrave and cornice moldings. There is no finish on the room 301 side of these studs, but the back side of the circular-sawn wood lath and plaster that forms the finish of room 302 is exposed between the studs.

Lay fiberglass batt insulation, 10" to 12" thick.

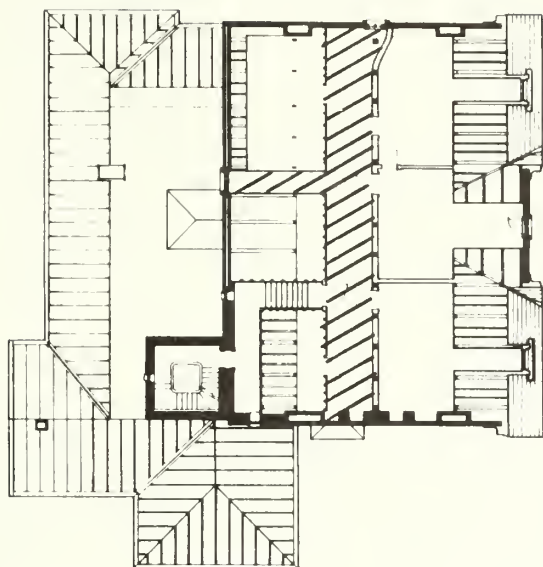
c. Room 302 - Hall

Room 302 is the T-shaped central hall of the third floor. The crossbar portion of the "T" is 6' 10" by 55'4" oriented in a north-south direction, just west of the center of the building (see IP060). The stem of the "T" is 3'1" by 12'10" and extends in a westerly direction to window 307 in the west gable.

The walls are whitewashed two-coat plaster on circular-sawn wood lath except for the north end wall, which is three-coat plaster on brick, and the south end wall, which is two-coat plaster on brick. The baseboards are simple, planed 5-1/4" by 1" boards that were used as the

- In traffic areas, install insulation boards that can withstand foot traffic, and provide R30 insulation.

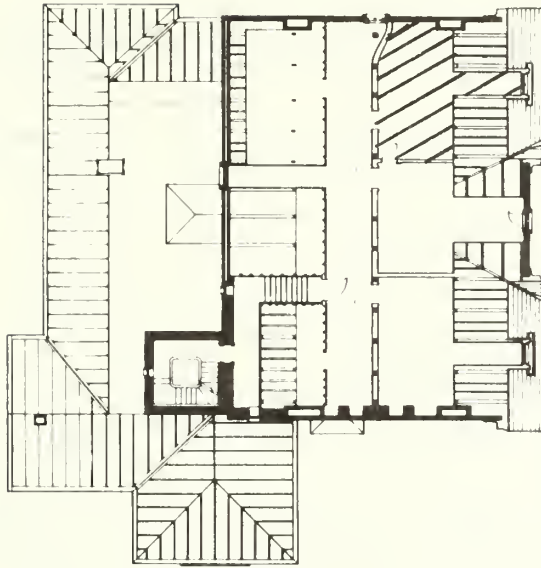
d. Room 303 - Servant's Chamber

Room 303 is in the northeast corner of the third floor. It is essentially an 11'1" by 19'6" rectangle with a 3'1" by 9'8" dormer extension to the east. The northeast chimney protrudes 2'6" by 1'4" into the northeast corner and the north end of the west wall curves into the room parallel to the wall of room 302. The room was probably used as a servants' bedroom during the historic period (see IP061).

The walls are the standard whitewashed two-coat plaster on circular-sawn wood lath found elsewhere on the third floor. The baseboards are simple planed boards. The east wall is 4'9"

Lay fiberglass batt insulation, 10" to 12" thick, on the floor.

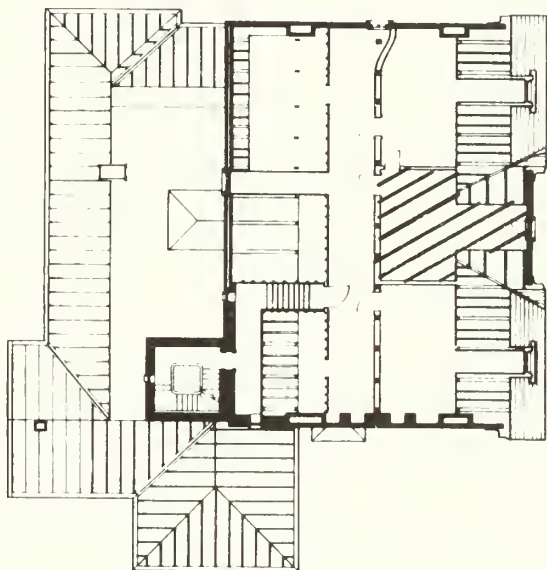
e. Room 304 - Servant's Chamber

Room 304 is the central attic room on the east side of the house. It consists of a main rectangle 11'1" by 15'11" with a rectangular space 7'6" by 10'0" adjoining it to the east (located under the gable; see IP063). This room was probably used as a servants' bedroom during the historic period.

Walls, floor, and ceiling are identical to those in room 303 with the following exceptions: In the north wall of the gable extension, a hole was cut to allow access to the former roof surface now covered by the ca. 1850 gable roof. In the south portion of the east wall, a hole was cut for

Lay fiberglass batt insulation, 10" to 12" thick, on the floor.

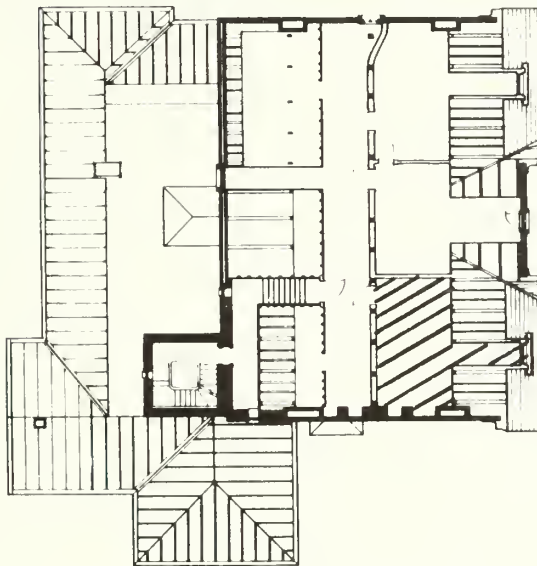
f. Room 305 - Servant's Chamber

Room 305 consists of an 11'1" by 18'7" rectangle with a smaller (3'1" by 9'8") rectangular dormer extension appended to its east side. The room occupies the southeast corner of the third floor. It, too, was probably used as a servants' bedroom during the historic period.

The walls, floor, and ceiling are identical to those in room 303 with the following exceptions: There is an access hole cut in the south portion of the east wall for access to room 313. The south wall contains two arched niches that support the rerouted flues. Plaster is missing from most of the ceiling in the south half of

Lay fiberglass batt insulation, 10" to 12" thick, on the floor.

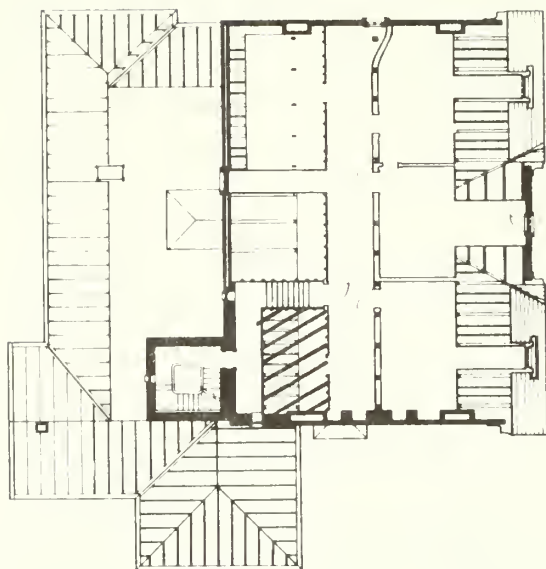
g. Room 306 - Attic

Room 306 is at the south end on the west side of room 302. It is 9'5" by 14'8". It was probably used for storage during the historic period.

The west, north, and east walls are exposed studs and the backside of circular-sawn wood lath and plaster. The east wall is 6'3" high, the west wall 2'9" high. The west wall transfers the load from roof rafters and floor joists down to the second-floor joists. Originally these loads were carried by the masonry west wall, but the ca. 1850 creation of room 307 required cutting the rafters and joists. The south wall is brick, the ca.

Lay fiberglass batt insulation, 10" to 12" thick.

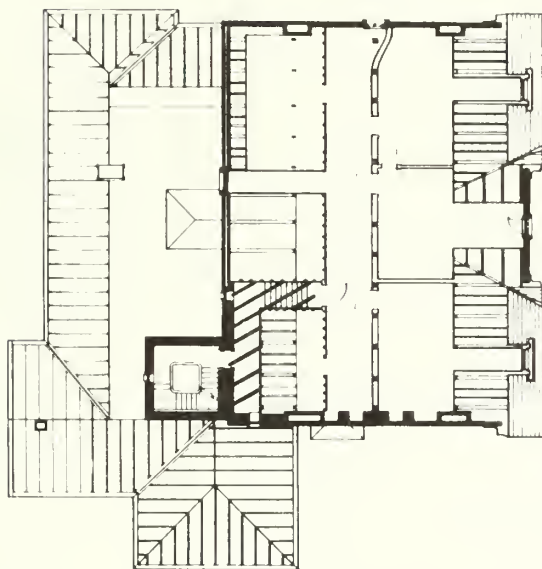
h. Room 307 - Hall

Room 307 is in the southwest corner of the third floor. It is L-shaped, with one leg 3'9" by 19'0" adjacent to the west exterior wall of the 1797 portion of the house (see IP064) and the other 3'7" by 9'1" projecting eastward from its north end (see IP065). This latter leg contains nine risers that connect the main area of the third floor with the lower level of the passageway and the adjacent landing to the tower stair (room 308). This room was created in the course of the ca. 1850 construction to provide access to the third floor from the new tower stair, thus allowing the earlier stair in the room 203 area to be removed. Its configuration

was dictated by the ca. 1797 roof construction, which limited the height of the ceiling of the western, passageway part, and the ceiling over the stairs.

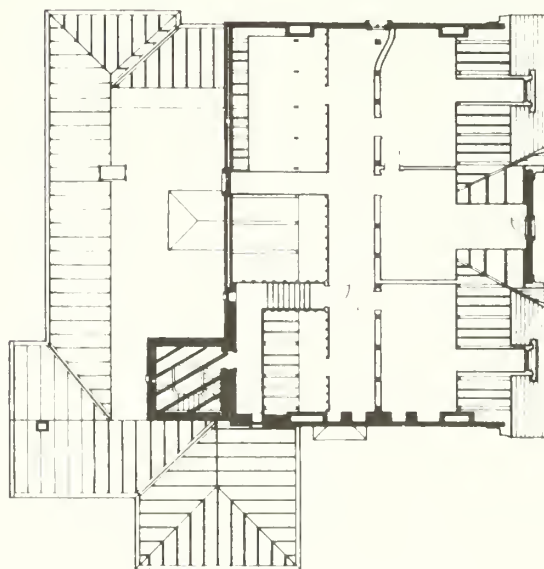
i. Room 308 - Tower Stair

Room 308 is the third-floor level of the tower stair. It is a square room approximately 9'8" by 9'10" whose only function was to provide vertical access to all the floors in the house.

The walls are a whitewashed three-coat plaster on wood lath on furring strips attached to the brick walls of the tower. The baseboard at the landing along the north wall and along the stairs below is the typical profile used in the more formal areas of the Upjohn (ca. 1849) addition. Along the east wall, above door 309 and all the way to the belvedere, the baseboard is the simple cavetto type found in the

The ceilings of this space are whitewashed two-coat plaster on wood lath attached to irregular nailers on the underside of the stair structure. The finished plaster follows the landings, straight runs, and winder portions of the stair in one smooth continuous surface with gradual transitions between areas of different slope and around corners. Some of this plaster has been damaged by water that penetrated through the tower deck. One already damaged area of plaster and lath was completely removed to allow an inspection of the stair structure (see IP-068, 069, and 070).

The preservation and restoration work recommended for room 308 includes the following items:

- Repair or replace all damaged or missing plaster or lath.

- Install a transparent barrier (of acrylic sheet) at the third-floor level to reduce heat loss through the tower, while maintaining visual continuity for visitors observing the tower stair from the first floor.

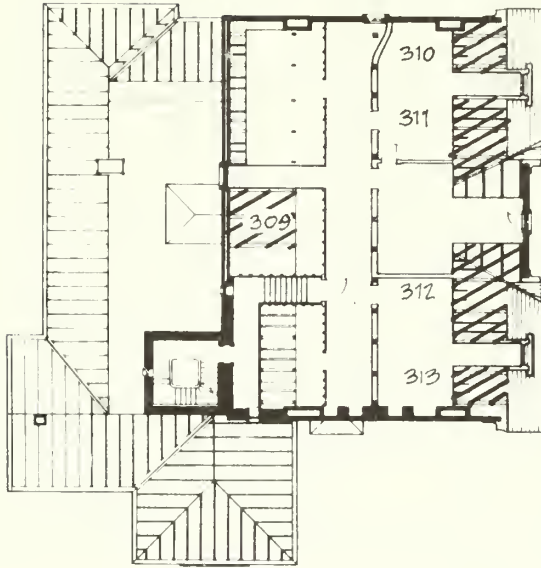
j. Rooms 309/310/311/312/313 - Attic

These rooms are not really rooms at all inasmuch as they were not intended for regular access. In fact, access was not possible until access holes (generally 1'6" by 2'0") were cut in the lath and plaster walls of the adjoining rooms.

The walls of these rooms were the unfinished back side of the lath and plaster walls of the adjoining rooms, except for the north wall of room 310 and the south wall of room 313, which were the exposed brick of the north and south gables, respectively (see IP066).

The following items of work are recommended for rooms 309, 310, 311, 312, and 313:

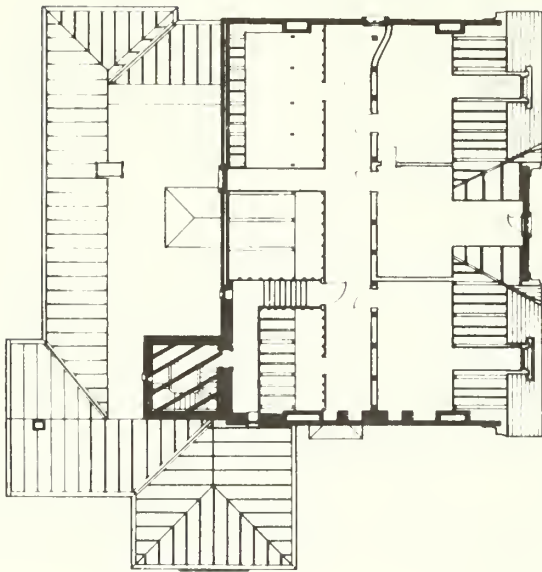
## 6. Fifth Floor - Belvedere

Room 501 is the open-air belvedere at the top of the ca. 1850 Italianate tower. The term "belvedere" is used because the only apparent historic function of the space was as a vantage point from which to enjoy the view of the Hudson River valley and the Catskill and Berkshire mountains.

The north and south walls are of solid brick construction with painted wood paneling as the interior finish. These walls carry roof loads down to the stronger, four-walled section of the tower below. The east and west walls are open with nonload-bearing columns at the middle of two arched openings and handrails

The preservation and restoration work recommended for room 501 includes the following items:
